Unplanned Interruption Report

For the Year End 31 March 2023

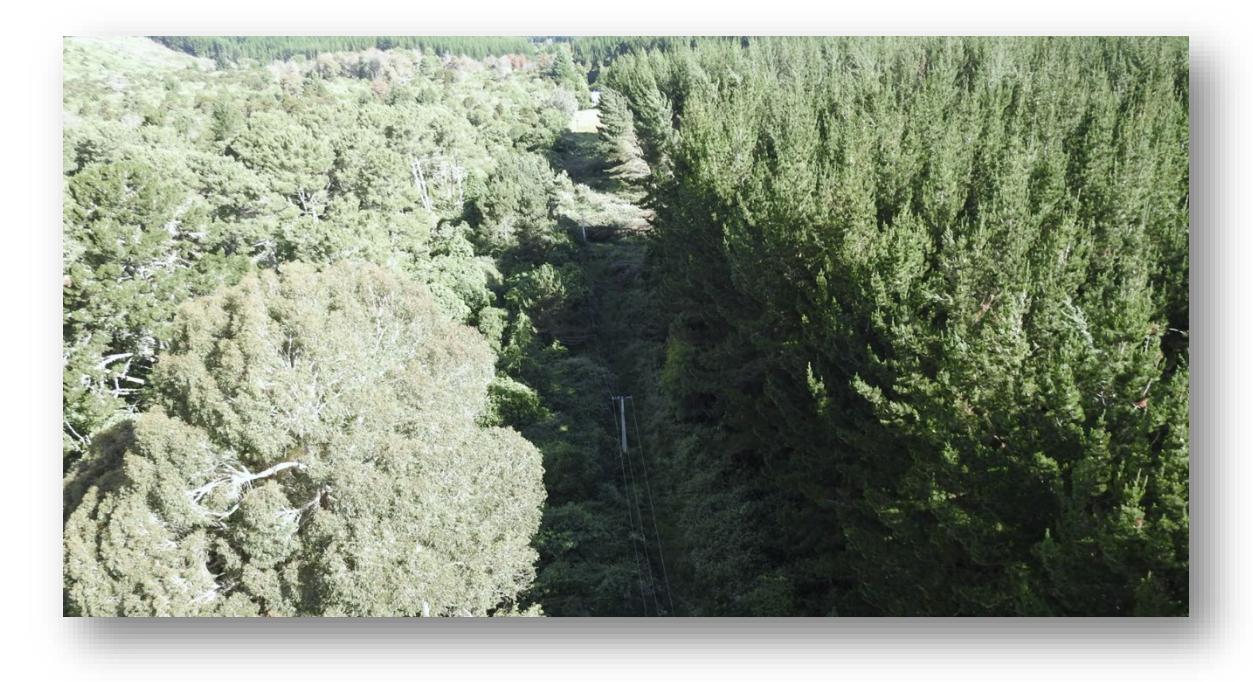
Figure 10: Example of a line corridor prior to a storm.

- Figure 10 shows a line corridor with a national park and commercial forest on either side.
 Figure 11 shows the same forest following a storm, with severe damage resulting primarily from the commercial forest.

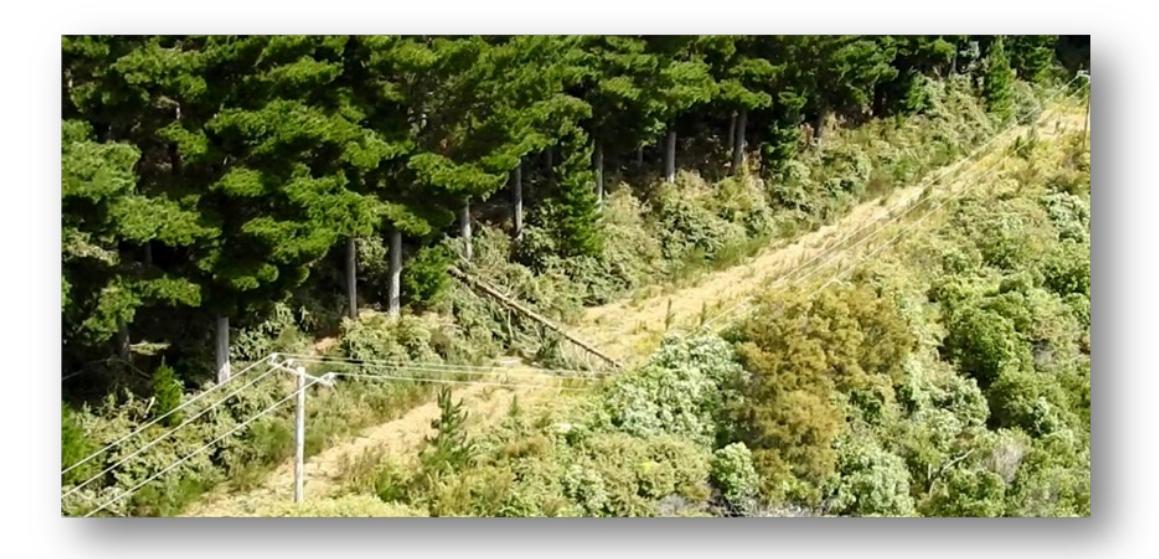
Figure 12: Example of tree damage from a plantation forest.

4. The density of commercial forest plantations means that internal trees have weak root structures and are extremely vulnerable to rain inundation and wind. Figure 12 shows an internal tree that has failed and fallen onto a line.

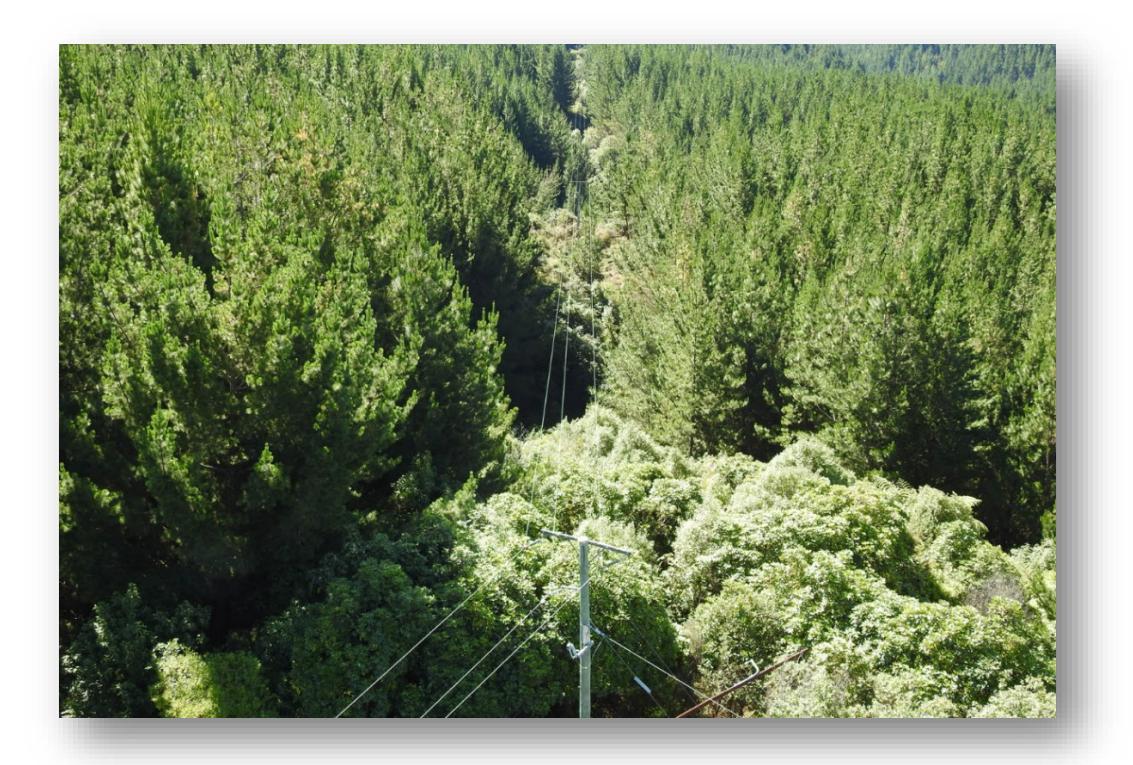
5. Vast areas of land are being converted from cleared land traditionally used for dairy or beef farming, to heavily forested areas to support carbon sequestration.

Figure 13: A line originally constructed on a farm that has been converted to a commercial forest.

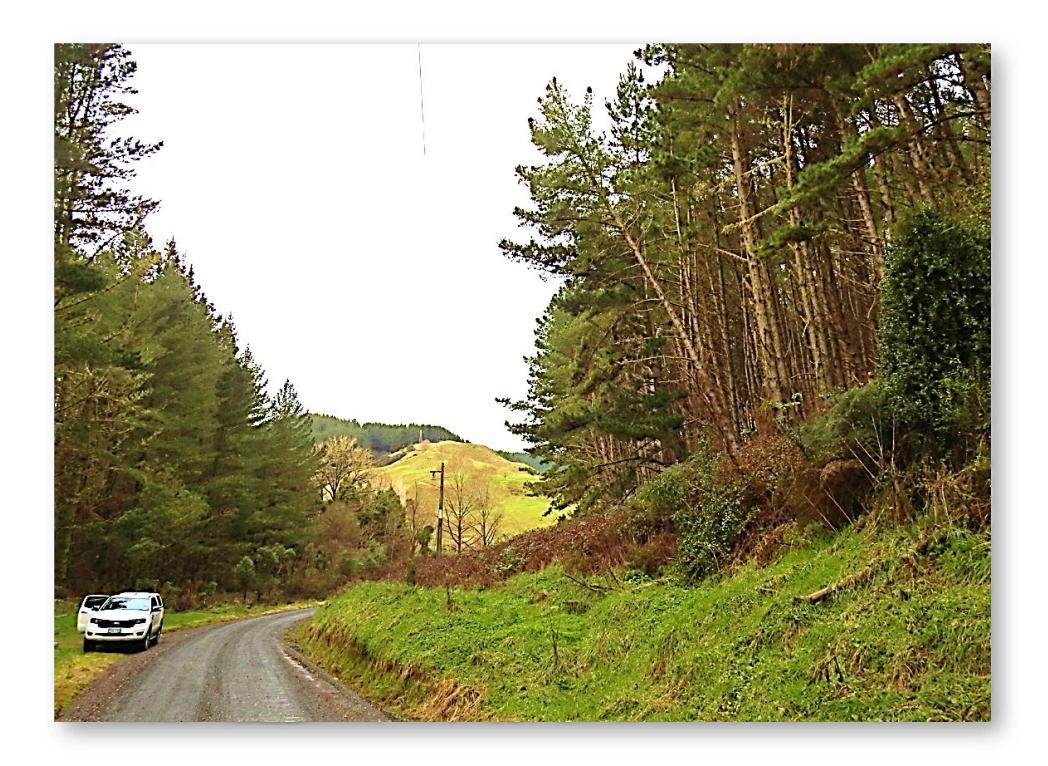
Figure 14: Example of tree at risk of falling onto a line following heavy rainfall.

6. Rain inundation destabilises root systems causing failure even without wind impacts. Figure 14 shows a tree that is at risk of falling onto a line following heavy rainfall.

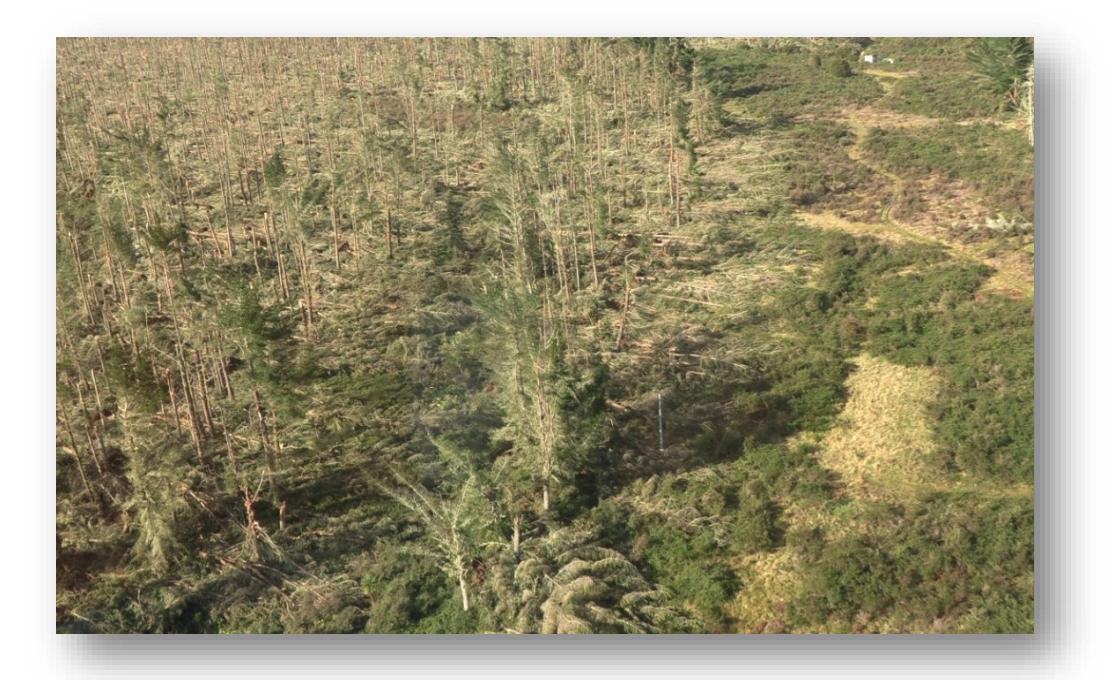
7. Forest structures fail completely under severe cyclones. During Cyclone Gabrielle vast areas of commercial forests were devastated, as pine trees snapped in half under heavy winds. TLC's network infrastructure was severely damaged as a result.

Figure 15: A commercial forest with most trees snapped following Cyclone Gabrielle

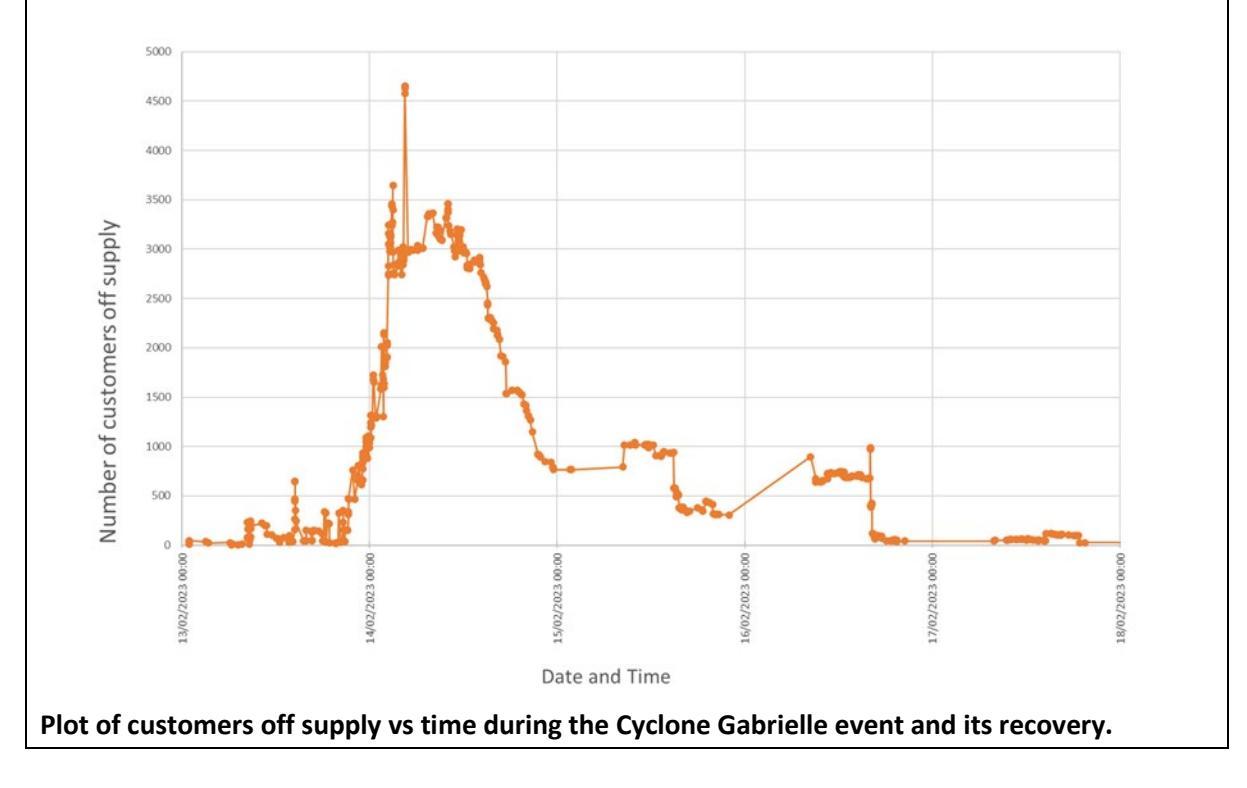
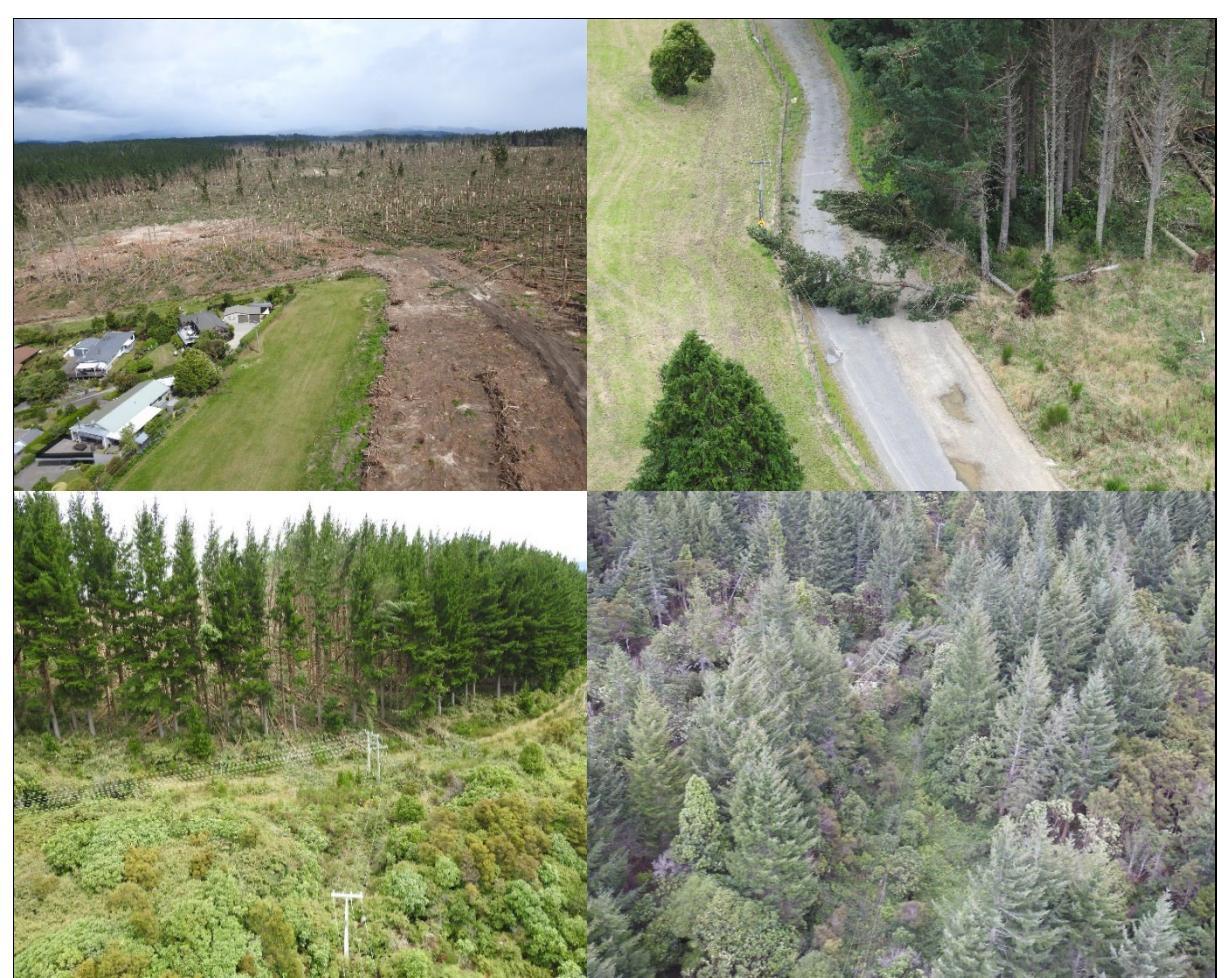
On the evening of February 13, 2023, New Zealand was hit by ex-tropical cyclone Gabrielle, resulting in heavy rainfall, strong winds, and coastal flooding in the North and Eastern regions of the North Island. While less affected than other areas in New Zealand, parts of The Lines Company's network sustained significant damage resulting in 4,650 customers being without power at the peak of the event. Recovery efforts were intensive, lasting several days due to the extensive damage to the network. Despite these challenges, 50% of customers had their power restored within 11 hours and 90% within 35 hours, as shown in Figure 1. This event was unprecedented in The Lines Company's recent history, and the high volume of incidents and extensive network damage placed a significant strain on the people, processes, and systems involved. The damage to the network was primarily caused by out-of-zone fallen trees.

Example photographs of typical network damaged that occurred during Cyclone Gabrielle.

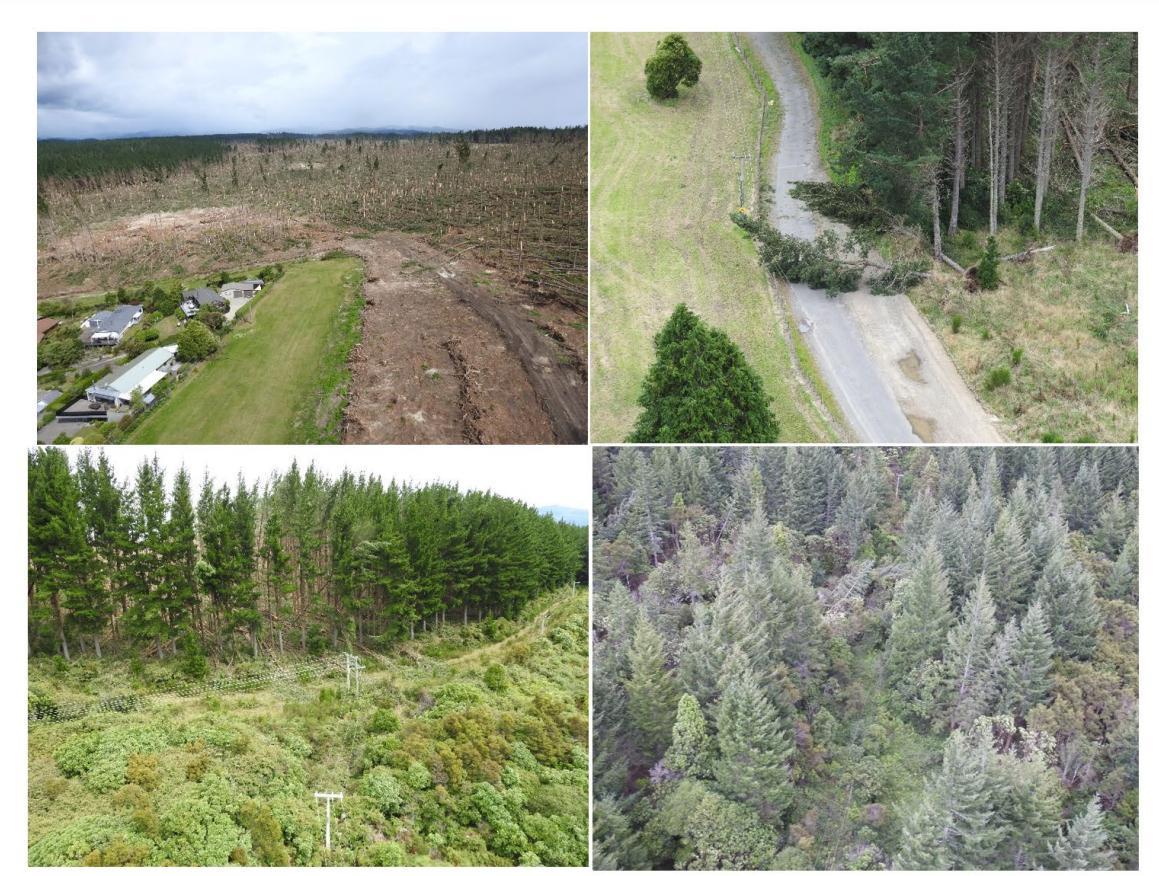
On the evening of February 13, 2023, New Zealand was hit by ex-tropical cyclone Gabrielle, resulting in heavy rainfall, strong winds, and coastal flooding in the North and Eastern regions of the North Island. While less affected than other areas in New Zealand, parts of The Lines Company's network sustained significant damage resulting in 4,650 customers being without power at the peak of the event. Recovery efforts were intensive, lasting several days due to the extensive damage to the network. Despite these challenges, 50% of customers had their power restored within 11 hours and 90% within 35 hours, as shown in Figure 1. This event was unprecedented in The Lines Company's recent history, and the high volume of incidents and extensive network damage placed a significant strain on the people, processes, and systems involved. The damage to the network was primarily caused by fallen trees, as illustrated in Figure 2.

Figure 2. Example photographs of typical network damaged that occurred during Cyclone Gabrielle.
