Unplanned Interruption Report

For the Year End 31 March 2023

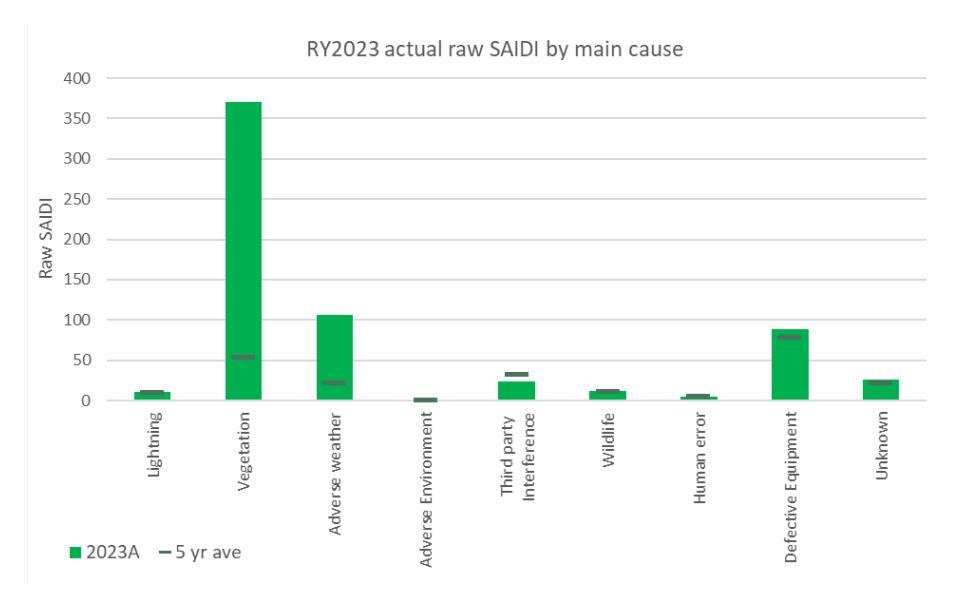
Figure 1: RY2023 raw SAIDI compared with the preceding 5-year average

Figure 1 shows the context of our unplanned Raw (non-normalised) SAIDI in RY2023 compared with the preceding five-year average. This includes the impact of Cyclone Gabrielle in February 2023, which was a rare event with a material impact on our total outage performance.

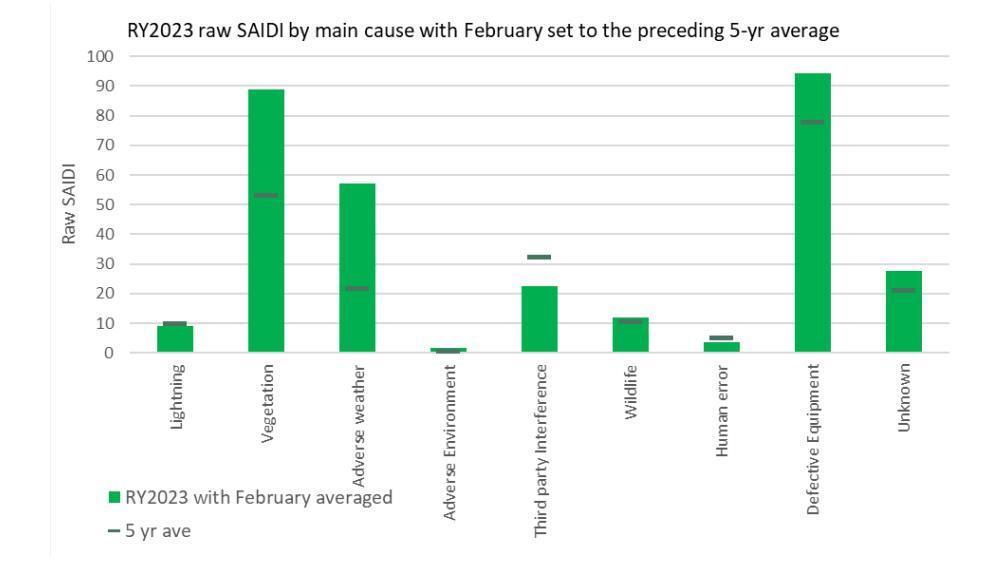
Figure 2: RY2023 raw SAIDI compared with February adjusted to the preceding 5-year average.

Figure 2 shows the total Raw (non-normalised) SAIDI with the impact of Cyclone Gabrielle removed. In this case we have replaced the February 2023 SAIDI with the preceding 5-year

average SAIDI for February. It shows that even without the impact of Cyclone Gabrielle, RY2023 was an extreme year dominated by vegetation interference and adverse weather conditions.

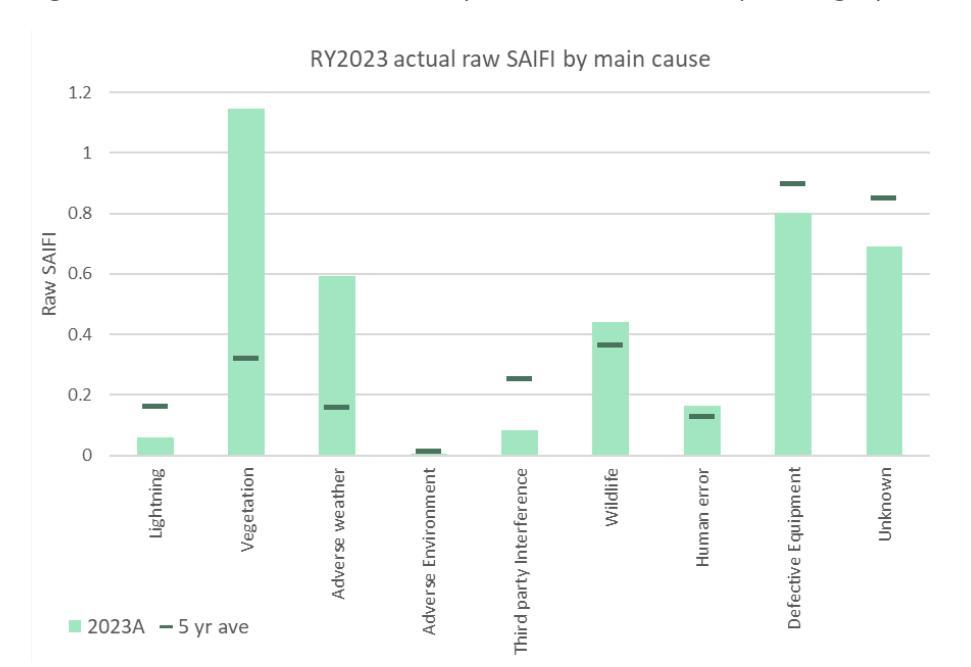
Figure 3: RY2023 raw SAIFI with February 2023 normalised to the preceding 5-year average.

Figure 3 shows the context of our unplanned Raw (non-normalised) SAIFI in RY2023 compared with the preceding five-year average (this includes the impact of Cyclone Gabrielle) and shows that adverse weather and vegetation were the primary drivers for SAIFI increases during the year.

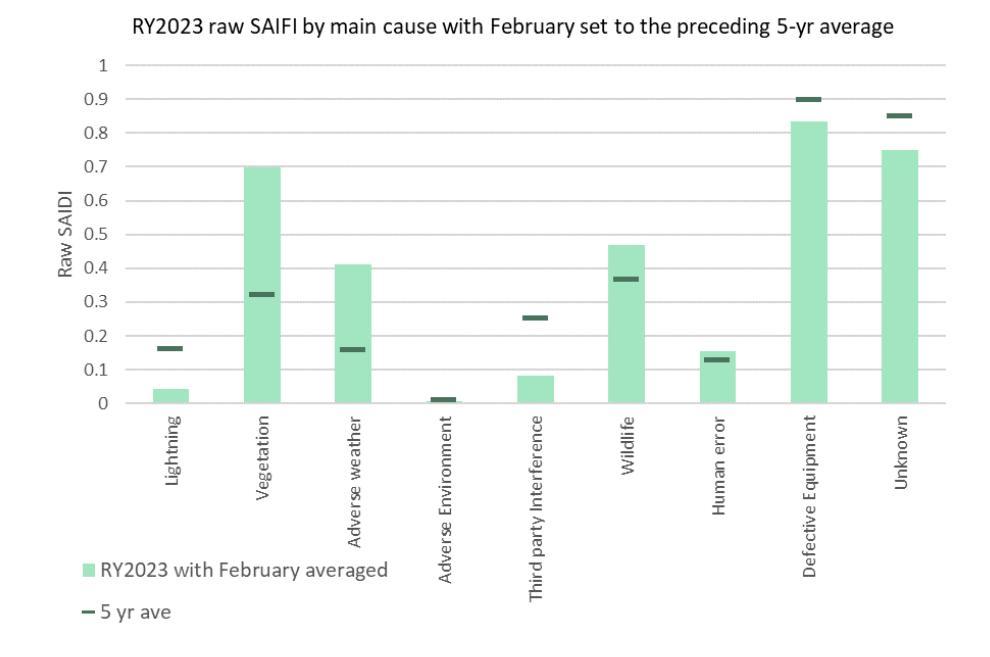
Figure 4: RY2023 raw SAIFI with February 2023 adjusted to the preceding 5-year average.

Figure 4 shows the total raw (non-normalised) SAIFI with the impact of Cyclone Gabrielle removed. It highlights that the core drivers of SAIFI during the year were the same and that Defective Equipment and Unknown Cause SAIFI were lower than the 5-year average.

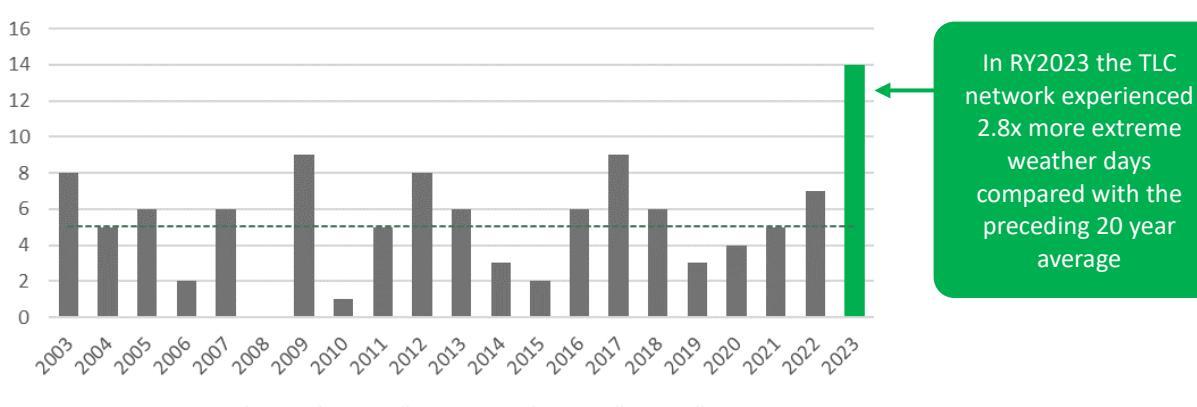
Figure 5: RY2023 – count of days when weather intensity exceeded the 95th percentile on the TLC network.

Figure 5 shows the count of days each year when weather intensity exceeded the 95th percentile over the last twenty years. It shows that RY2023 had the most extreme weather days of any year in the last twenty years. The total count of extreme weather days was roughly 2.8x the preceding twenty-year average. NIWA's analysis has also confirmed that in fact RY2023 had the most extreme weather days since records began in 1940 when measured at the 95th percentile.

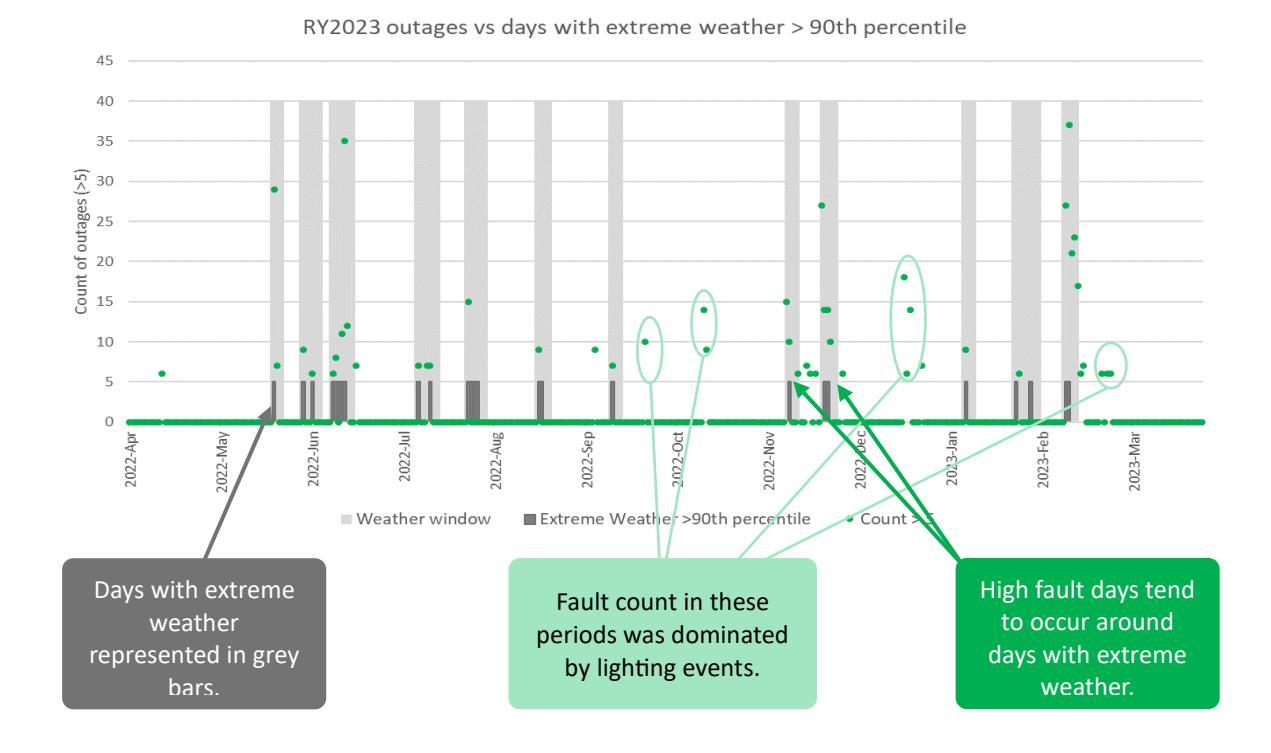
Figure 6: RY2023 – correlation of days when weather exceeded the 90th percentile on the TLC network and fault count

Figure 6 shows that there is a strong correlation between extreme weather days in RY2023 and the number of days with high outages.

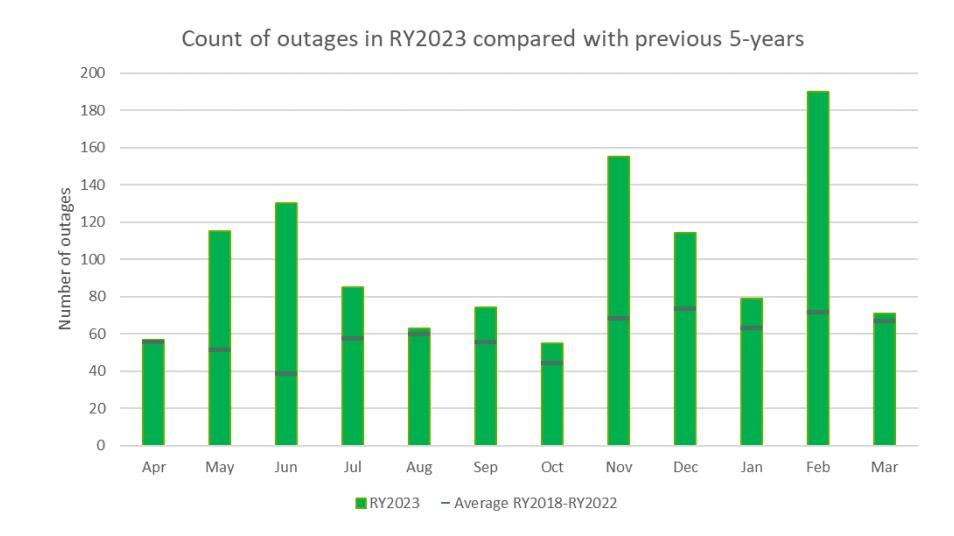
Figure 7: RY2023 count of outages compared with the preceding 5-year average.

Figure 7 provides a consolidated comparison of RY2023 compared with TLC's historic performance, showing the count of outages in RY2023 compared with the preceding five-year average. This demonstrates that the fault count was consistently high across the RY2023 year, and not confined to individual months.

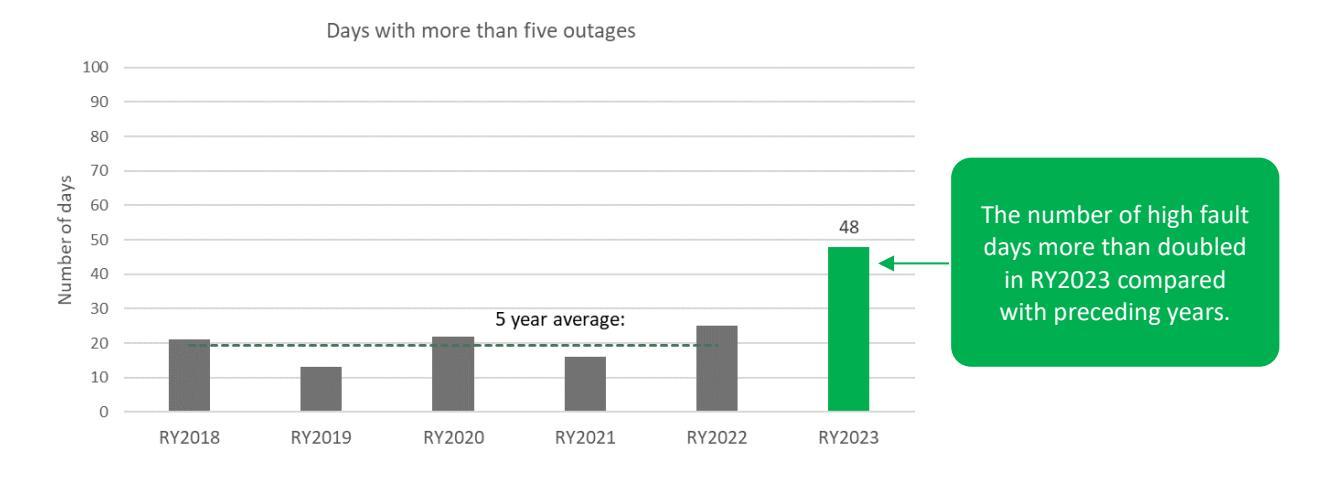
Figure 8: Number of days with more than five outages.

Days with extreme weather generate multiple faults, so we can also get an indicative view of weather impacts by assessing the count of outages per day where the fault count is high. TLC typically experiences around 20 days per year when the fault count exceeds five faults per day. Figure 8 shows that in RY2023 TLC experienced 47 high-fault days. Although this is only an indicative measure of the impact of weather on our network, it demonstrates the significant difference of RY2023 compared with TLC's historic trends.

We note from this analysis that electricity distributors, including TLC, are typically sized to manage an average year of outages. Although there is some ability to stretch capacity for unusual years, the volume of high fault days in RY2023 was beyond expected operating capacity. This impacted TLC's response to faults, especially in regard to managing fatigue. Under these circumstances the average time to restore faults typically increases during high fault days. Figure 8 shows context of high fault days TLC experienced on its network in RY2023. It shows that the number of days with high fault counts more than doubled in RY2023 compared with the preceding five-year average.

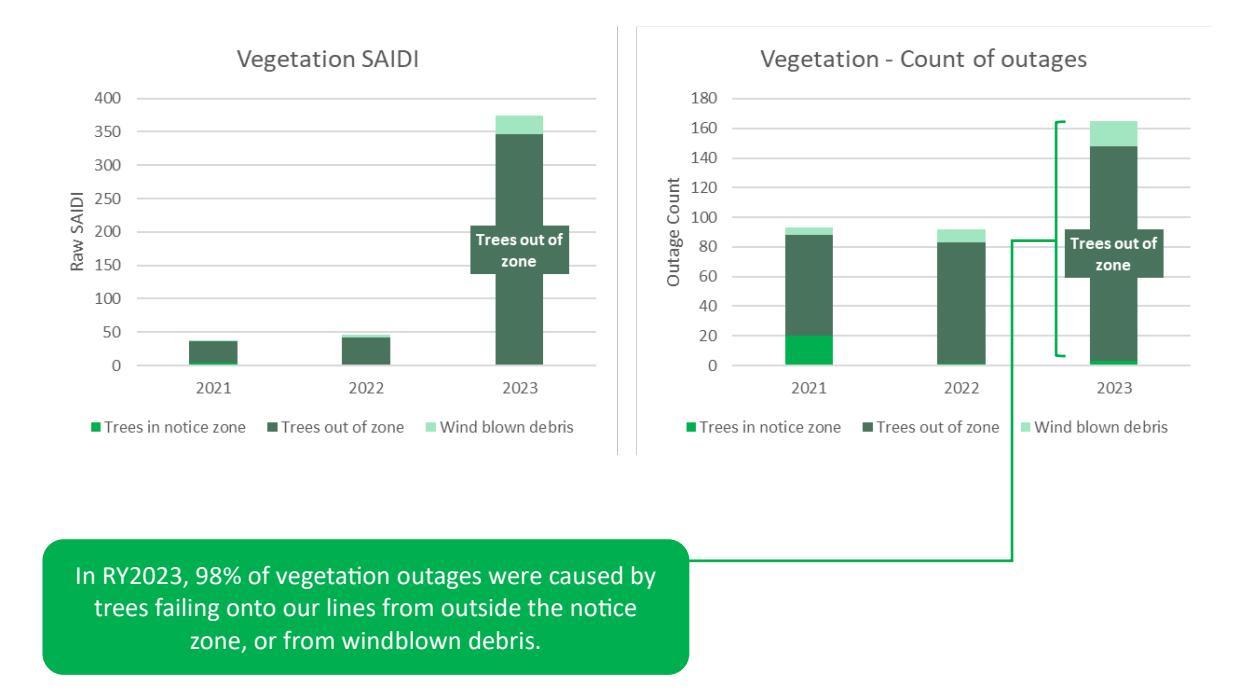
Figure 9: Vegetation outages in RY2023

RY2023 also saw an increase in vegetation interference due to out of growth limit zone compared with prior years. In 2021, we extended our fault reporting to capture more detail on vegetation interference, which has shown that more than 90% of our vegetation interference is caused by trees falling onto lines from outside the GLZ notice zone. Figure *9* shows that in RY2023 98% of vegetation outages were caused by out of zone tree fall.

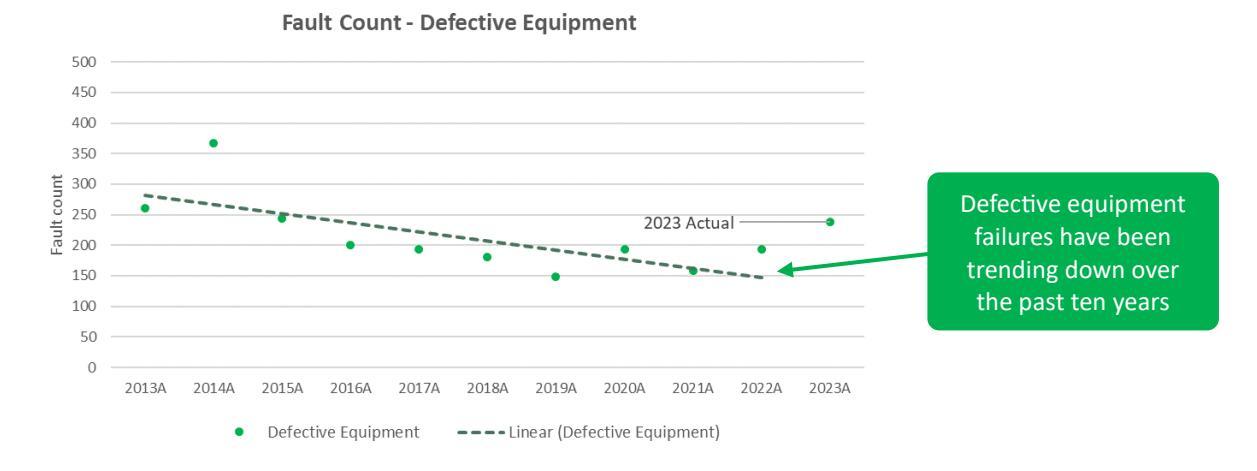
Figure 16: Defective equipment fault count trends

We assess that defective equipment was a secondary factor in our SAIDI performance in RY2023. Defective equipment faults were elevated in RY2023 but remained generally consistent with historic performance despite the effects of Cyclone Gabrielle. However, the SAIDI impact from the defective equipment faults was minor in comparison with the primary drivers (weather and vegetation). Figure 16 shows that defective equipment fault count has been trending down over the last decade. Although RY2023 saw an increase in defective equipment outages, the increase was relatively low and proportional to the significant increase in extreme weather experienced on the network.

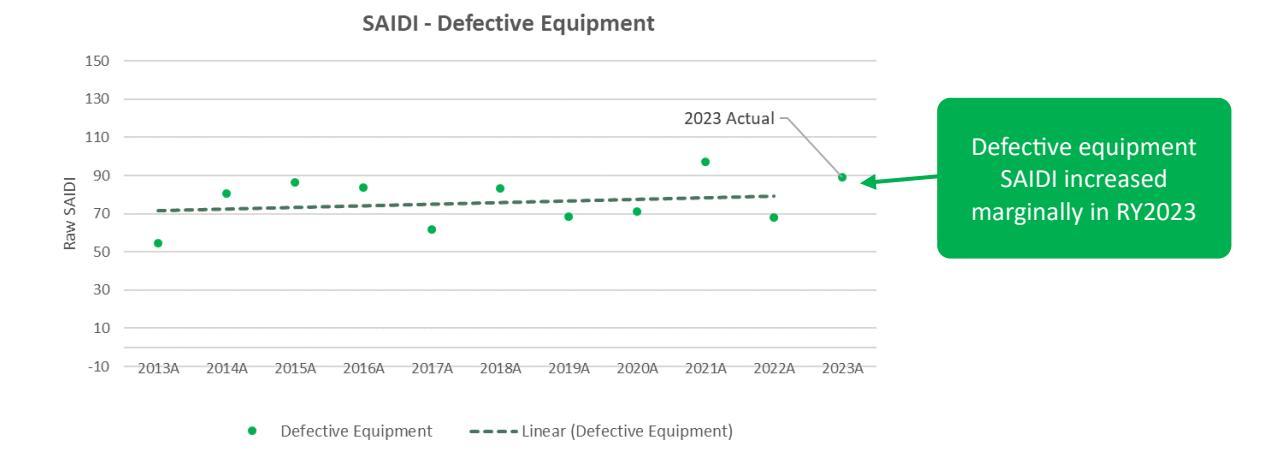
Figure 17: Defective equipment SAIDI trends.

In general, Defective Equipment outages correlate strongly with weather intensity. For context, typical common failure modes seen on distribution equipment as a result of severe weather are:

Addressing these common failure modes is part of TLC's ongoing renewal programme discussed later in this report.

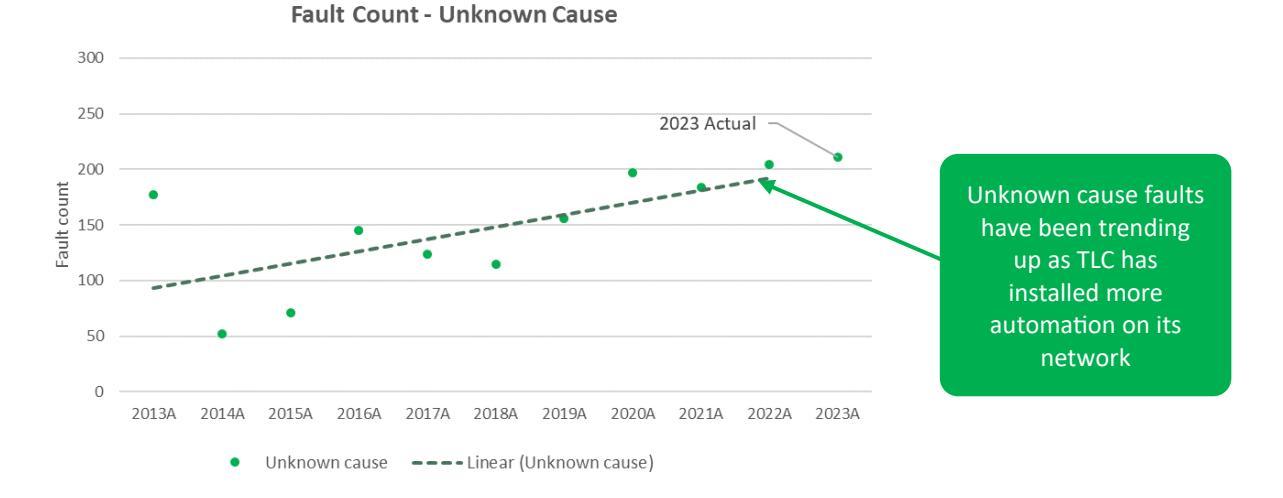
Unknown cause fault count has, in general, been trending up. This is likely, in part, driven by our automation programme, which has seen a significant number of new auto-reclose switches on our network in an attempt to reduce SAIDI and the effect of an extended outage on customers. Figure 18: Unknown cause fault count trends.

SAIDI from unknown cause faults has been trending up over the last ten years despite the improvements brought along with the automation programme. We believe that in part this is because we have also introduced new health and safety processes (such as blind closing and fire management policies) that require longer wait times before initiating a reclose. Figure 18 shows that the unknown cause fault count in FY23 was generally consistent with prior years, and

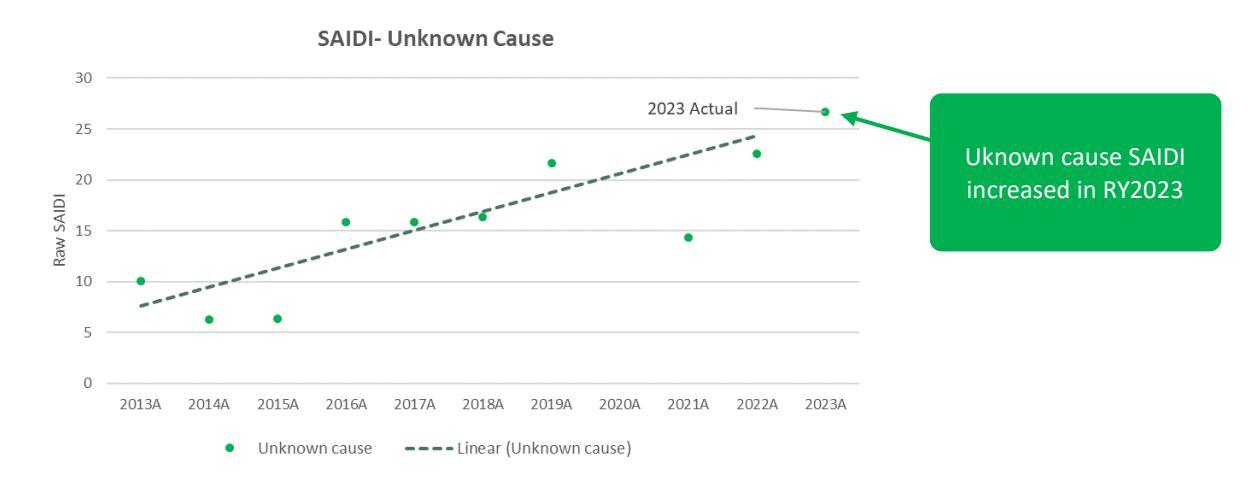
Figure 19: Unknown cause SAIDI trends.

Figure 19 shows that Unknown cause SAIDI was slightly elevated.

Our assessment is that while unknown cause faults were a contributor to the increase in SAIDI in RY2023, they were not a primary driver, and would have been exacerbated by weather and vegetation impacts discussed earlier.

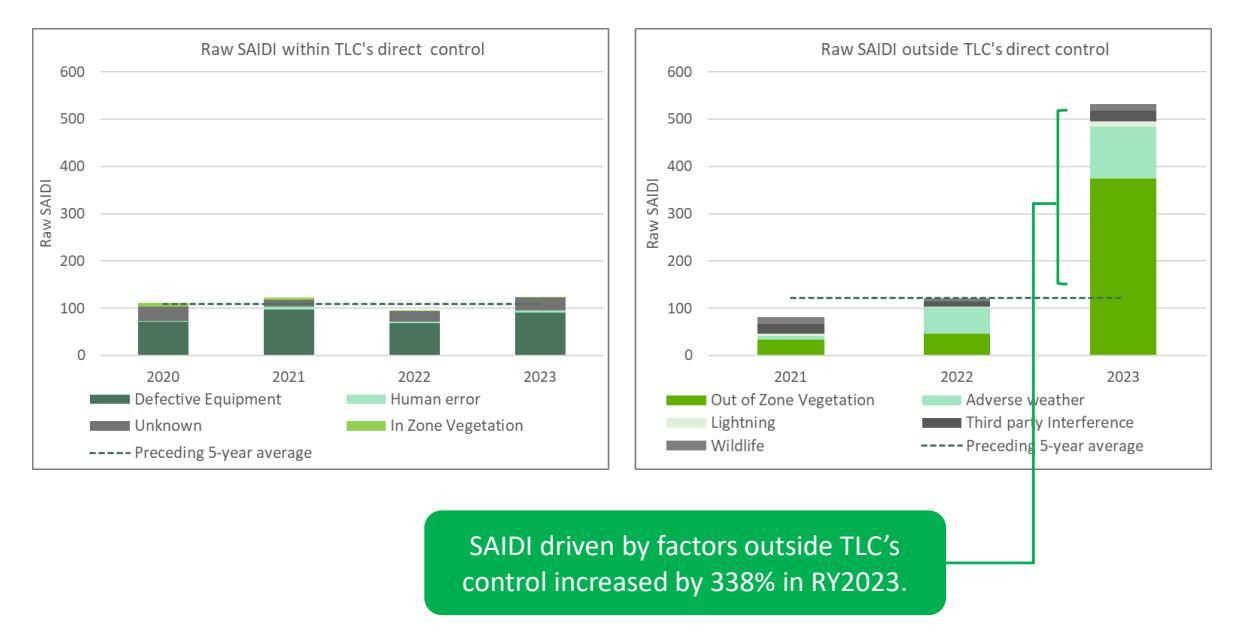
Figure 20: RY2023 Raw SAIDI within and outside TLC's direct control.

Figure 20 shows this graphically. In total, SAIDI driven by factors outside TLC's control increased by an average of 338% and SAIDI driven by factors inside TLC's control increased by 13% during RY2023.

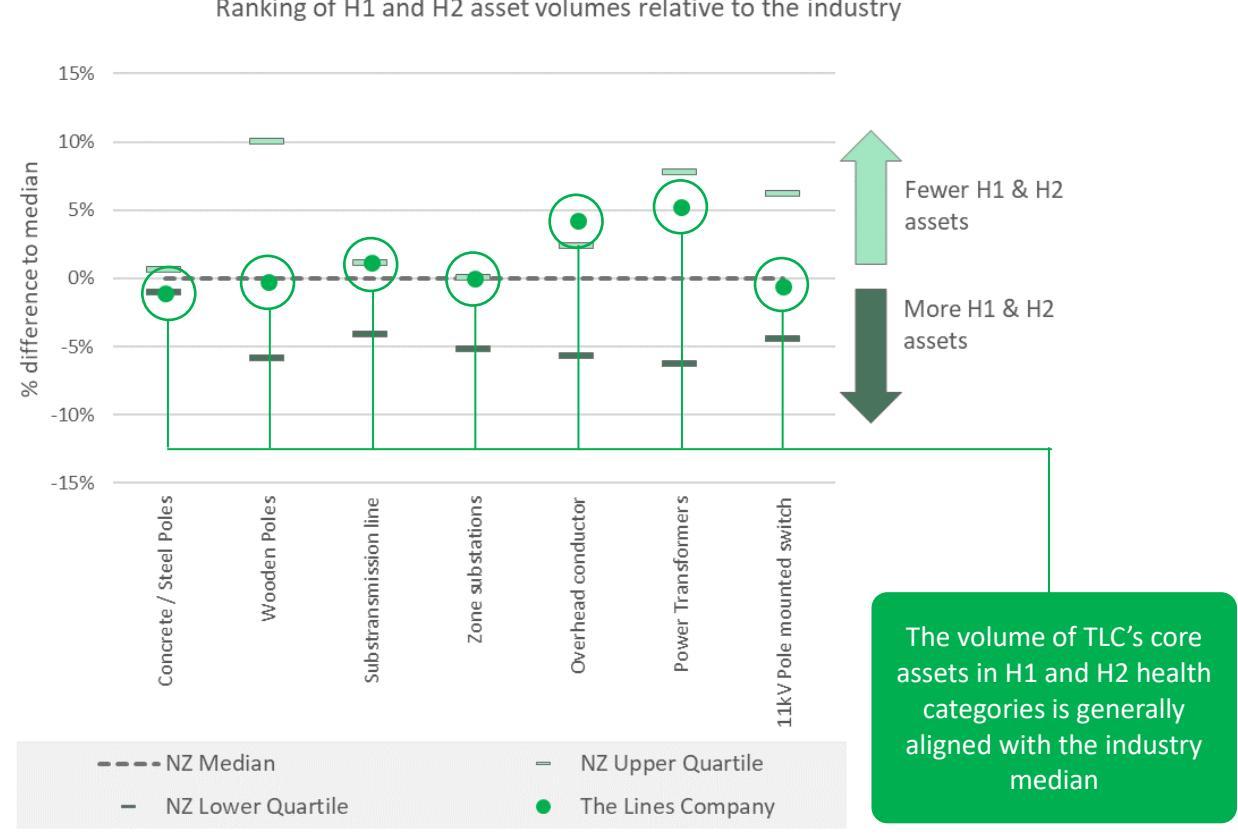
Figure 22: How the condition of TLC's key asset condition ranks against NZ Electricity Distributors

We analysed TLC's key assets to determine if TLC's proportion of H1 and H2 assets are aligned with industry. Figure 22 shows that TLC's proportion of H1 and H2 assets within its key asset groups are broadly aligned with the industry median.

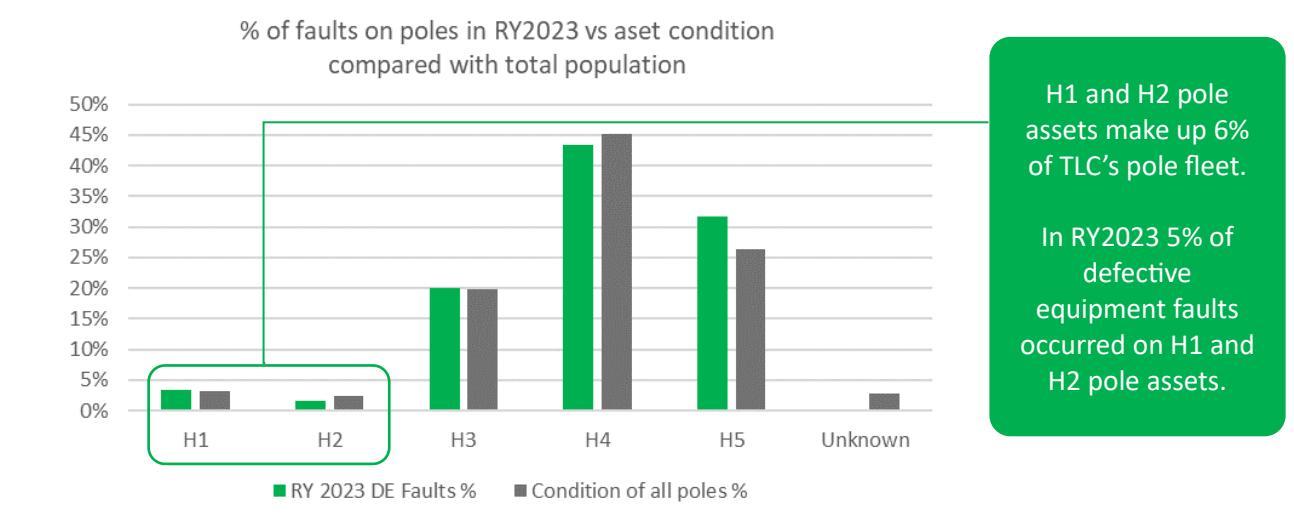
Figure 23: RY2023 faults on poles across health grades

Figure 23 shows that faults that occurred on TLC's poles during RY2023 were approximately proportional to the pole population across all asset grades. There was no identifiable concentration of faults in H1 and H2 asset groups.

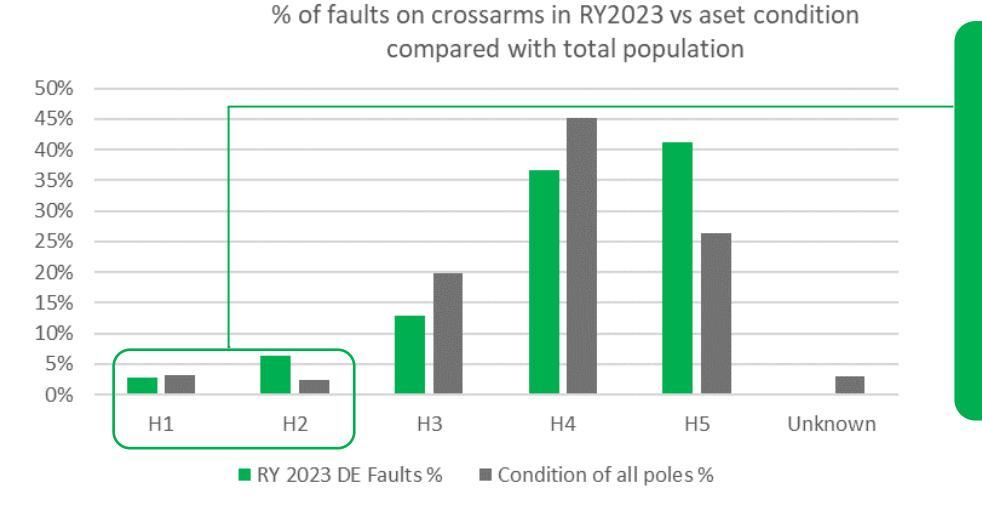
Figure 24: RY2023 faults on crossarms across health grades

Figure 24 shows the same analysis and outcome for crossarm assets.

H1 and H2 crossarm assets make up 9% of TLC's crossarm fleet.

In RY2023 9% of defective equipment faults occurred on H1 and H2 crossarm assets.

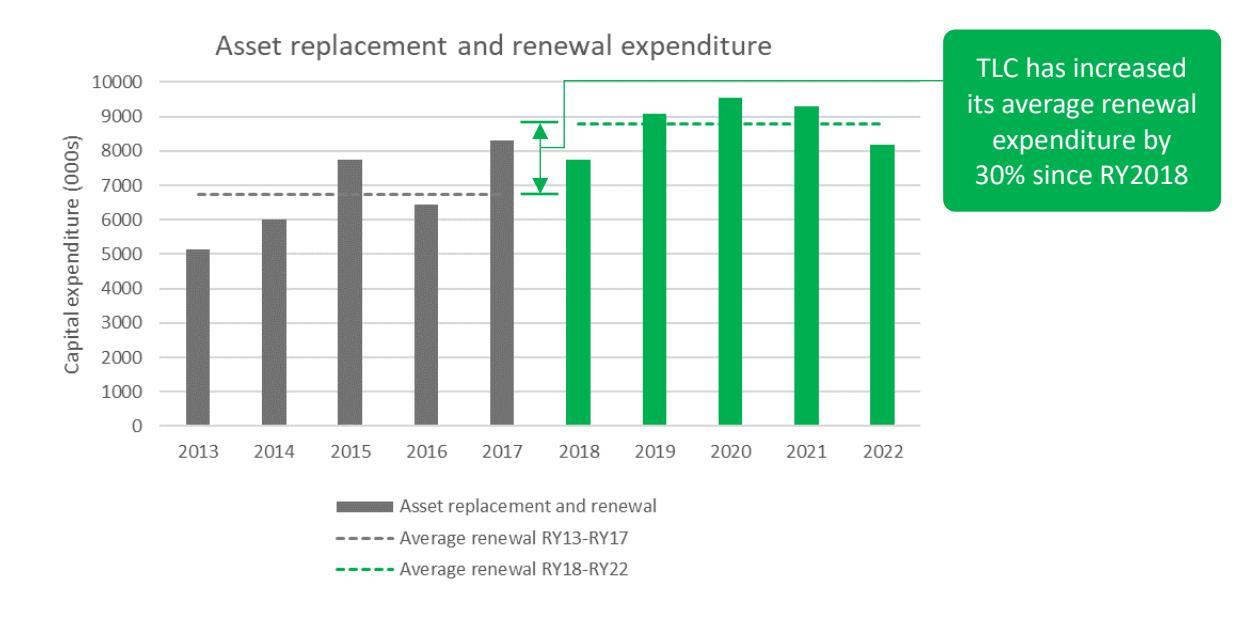
Figure 25: Asset replacement and renewal expenditure for the preceding ten-year period

Since 2018 we have accelerated our renewal expenditure. Figure 11 shows that asset renewal expenditure increased by 30% from an average of \$6.7m (RY2010 to RY2017) to \$8.8m (RY2018 to RY2023).

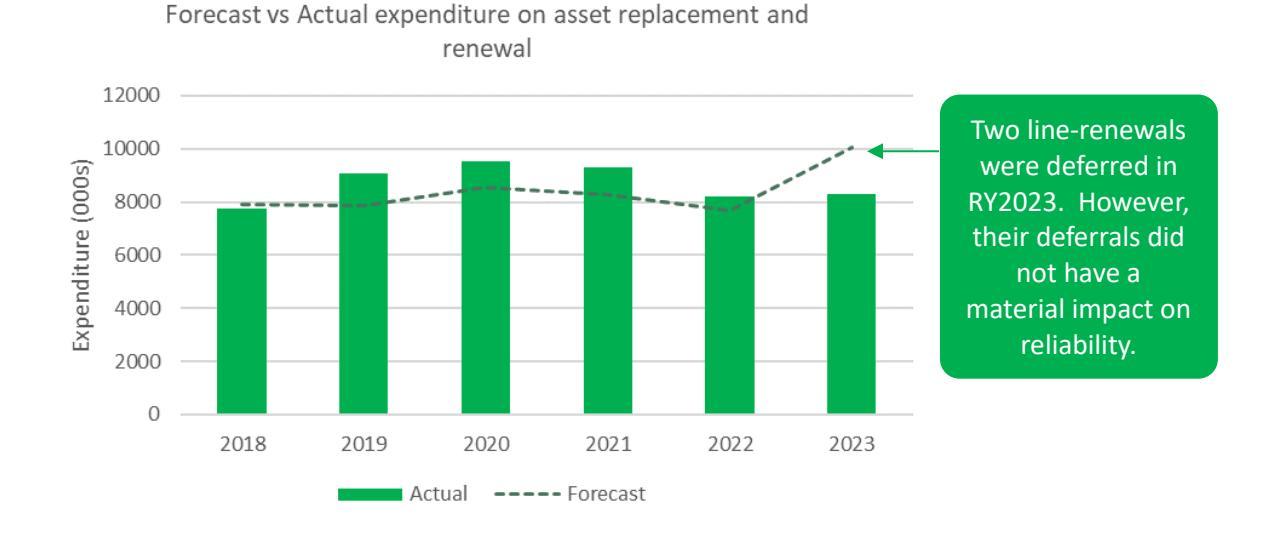
Figure 26: Asset replacement and renewal expenditure - actual vs forecast

Since 2018 we have sought to prioritise renewal of overhead lines and projects to strengthen security of supply. Figure 26 shows that our forecast renewal expenditure is in general, being consistently achieved through delivery⁵.

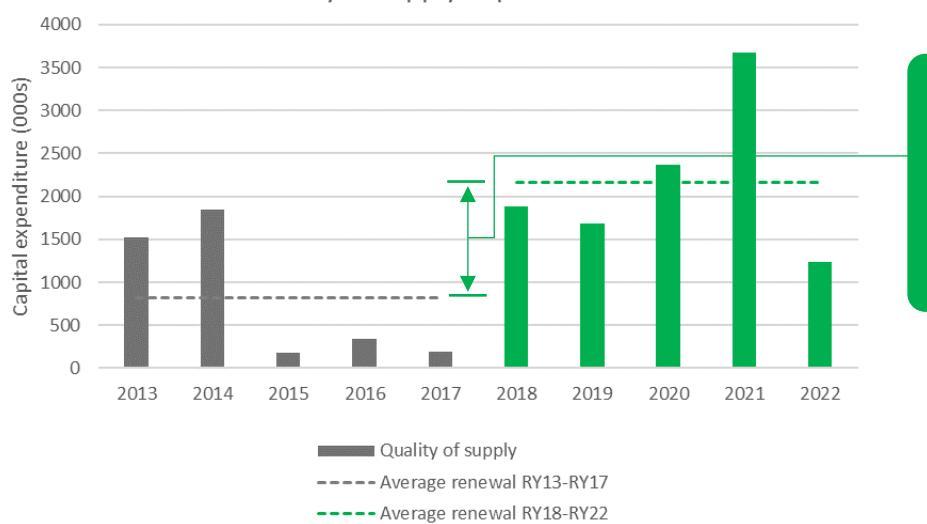
Since RY2018 we have also materially increased expenditure on quality of supply. This has included a specific programme to increase the automation and sectionalisation of our network by installing automated switches to isolate faults from higher population centres.
Figure 28: Quality of supply expenditure for the preceding ten-year period.

TLC has increased its average quality of supply expenditure by 166% since RY2018.

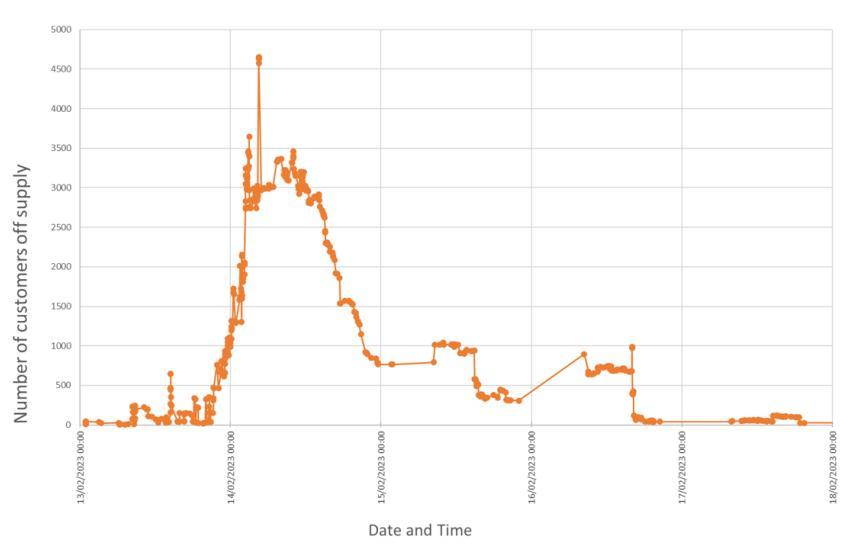
Figure 1 Plot of customers off supply vs time during the Cyclone Gabrielle event and its recovery.

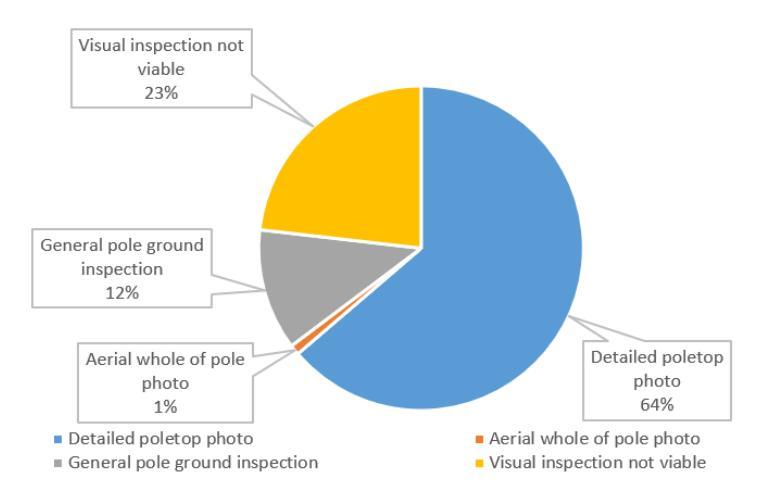
Figure 1. below shows the proportion of failure causes grouped by the proposed inspection method and quantified by SAIDI for all failure causes. It should be noted that this chart does not consider the effectiveness of the inspection method, and so the chart cannot be interpreted as indicating that

Figure 1. Proportion of SAIDI that potentially may be detected by the inspection method. Note the detection reliability of inspections is related to the task activity and its inspection interval and varies greatly depending on the failure mode being considered. See Appendix 1 for details.

all potential SAIDI producing defects can be detected and prevented, rather it indicates the proportion of SAIDI for which the inspection method is considered most appropriate.

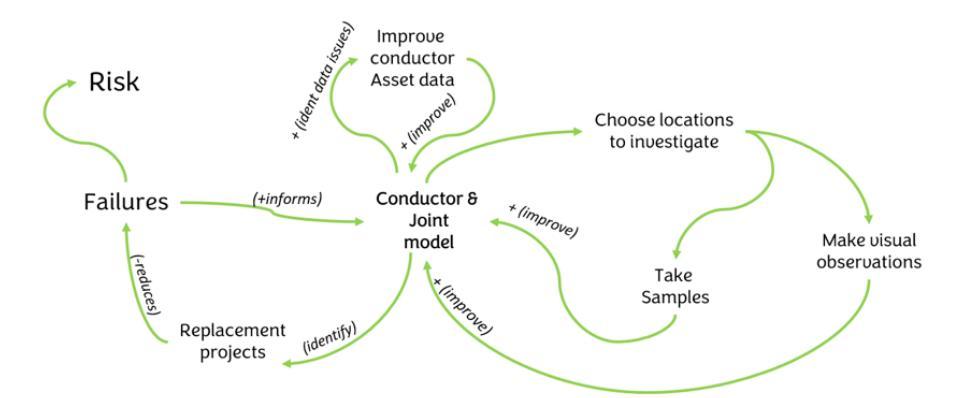
An approach that has been used to address this problem by other EDB's is to develop a model to predict conductor and joint health based on contributing variables. While it is likely that data to build such a model is initially sparse, an appropriate model can be the focal point for a program of continuous improvement that progressively collects data and improves the quality of decisions to address issues. A systems analysis diagram illustrating how such a model could be used to progressively understand and address the conductor joint problem is shown in Figure 2 below. Such a model could likely be implemented using the existing modelling platform, Asset Altitude.

Figure 2. System diagram illustrating how conductor modelling can be used to address conductor and joint failure problems.
